Re: 2267 Gerrard Street East: Item 14:

1.0 Background to the Report

**AREA 2276 Gerrard Street East –
Conditions Assessment Report**

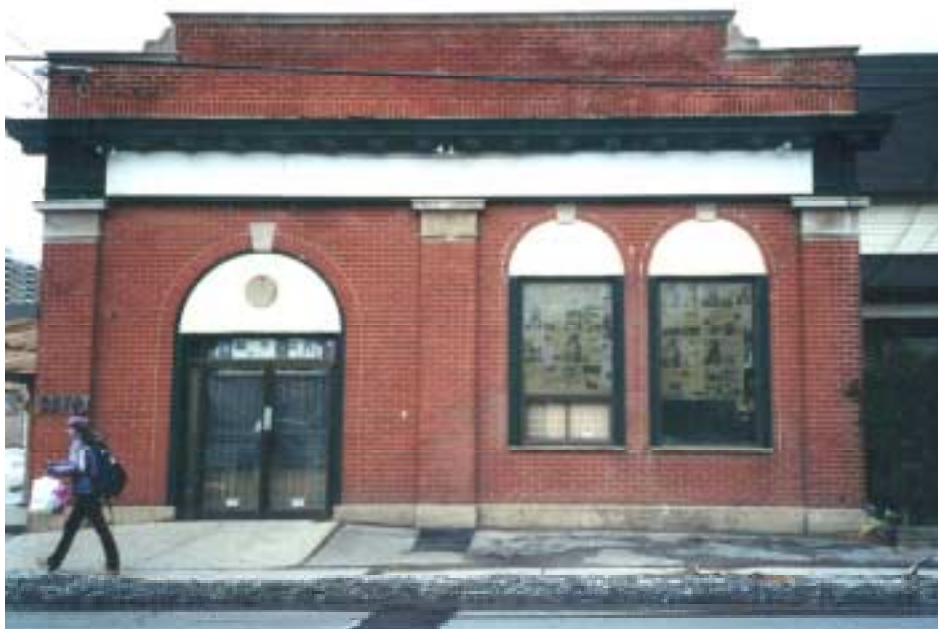
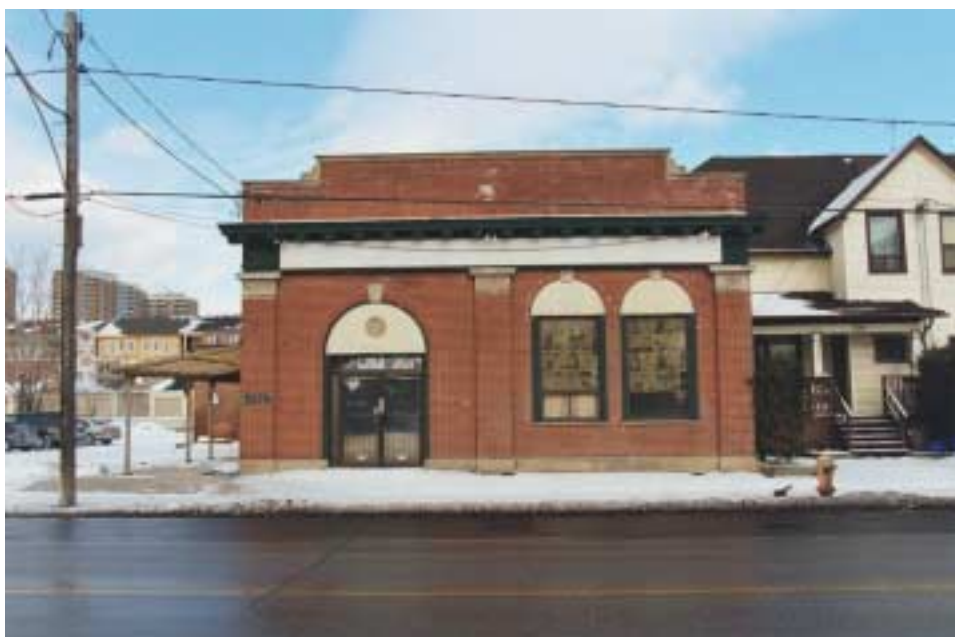
Figures 1& 2 Principal South Facade

The Reasons for Listing identify the “heritage attributes of the building...on the principal (south) façade.” However, it is not certain when this façade was designed or if it was even associated with the Lake Simcoe Ice Company branch office. The research tools employed for the listing report are written or plan-based and cannot identify the date or building use at the time that the current façade design was built. The current south elevation could conceivably have been added as a brick veneer refacing after the ice house ceased operation. This scenario seems credible if a more retail-oriented business replaced the ice house which would have been considered an industrial use.

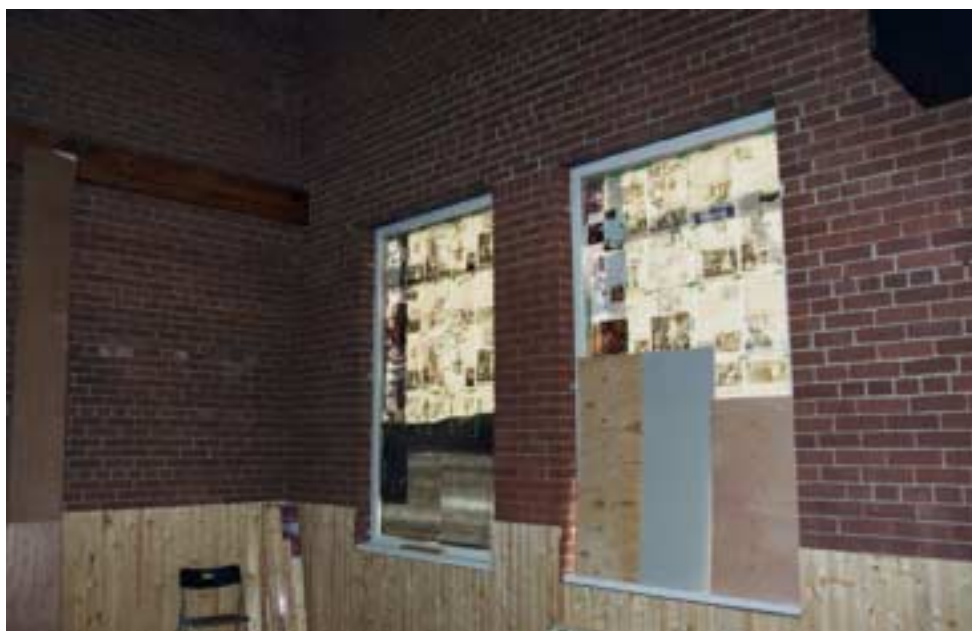
In looking at the west building elevation (Fig. 3), the return of the front façade exhibits a distinctly different brick than the side wall beside it. On the interior face of the south front wall (Fig. 4), the head of the apertures are flat with a steel supporting lintel. This wall construction diverges from the “round-arched openings” on the exterior face which are identified in the listing report as heritage attributes. This veneer brick arch treatment lends some credence to the scenario of a facade refacing possibly after the discontinuation of the ice house use. The door and window openings are supported at the top by steel lintels permitting the flat head of the back-up masonry. It is unusual for Edwardian Classicism, as an early 20th century style, and its associated building technology to feature an arch in elevation which is not similarly constructed on the interior wythe.

Figure 4 Interior face of South Facade

The interior face of the south façade (Fig. 4) provides other evidence of the previous garage door. The brick pier between the windows, as on the exterior, is a different brick than the rest of this south wall. Prior to the insertion of the middle pier, the steel lintel, described in the section above, supported the entire span across the two windows. This construction of the opening suggests that, not only the 1988 windows, but also the round arches over them were not intrinsic to the original façade which contained the garage opening.

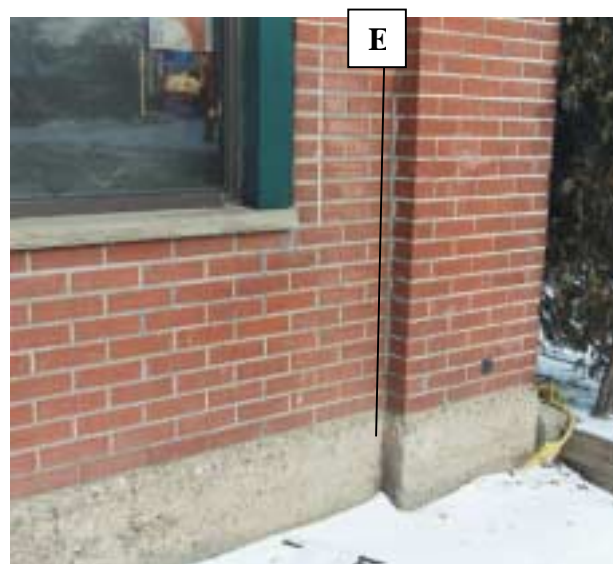
- Where the recessed wall meets the piers adjacent to what was once a garage door opening (line D, Fig. 6 & line E, Fig.7); and
- at the top of the middle pier between the two window openings (line C, Fig. 5).

The brick below the windows and partway up their jambs and the pre-cast concrete sills (Fig. 6 & 7) are all new and relate to the alteration of the former garage opening.

Figure 7 Pier adjacent to former garage opening
E – Line between new & old masonry

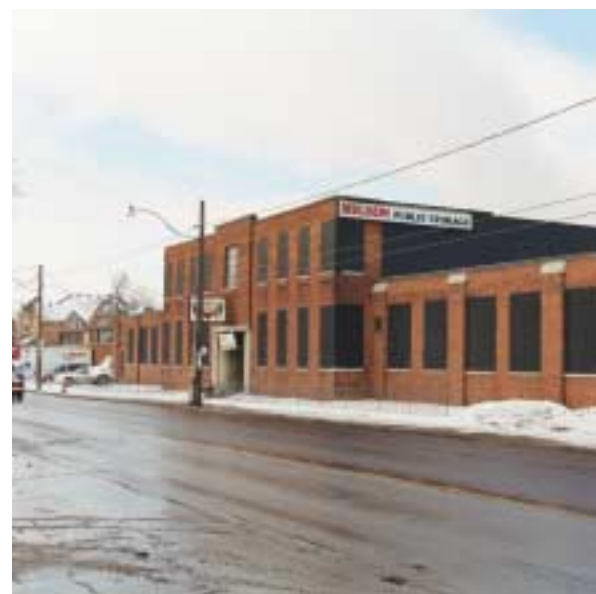
The combination of office and industrial uses tends to produce a more appealing street front than an industrial building alone. A nearby example of this type of building can be found further east at 2356 Gerrard Street East which is presently a storage rental business but was originally a glove factory (Fig. 9). This building façade’s scale and design detail--- such as corbelled brick bands, a stone entrance portico, horizontal window mullions and stone capped pilasters--- exhibits the quality of a commercial building which is at least equal to the subject property. The latter façade, however, is original to a mixed commercial-industrial property whereas the subject building was modified after the industrial use ceased.

Figure 9 2356 Gerrard St. E., former glove factory
